**WEST VIRGINIA DEPARTMENT OF ENVIRONMENTAL PROTECTION
WV OIL AND GAS CONSTRUCTION STORMWATER PERMIT**

FACILITY NAME:	Mountain Valley Pipeline Project			REG. #	EXPIRE DATE:
PERMITTEE	MOUNTAIN VALLEY PIPELINE, LLC			WVR310667	12/1/2020
ADDRESS/PHONE:	Attn: MATTHEW HOOVER 625 LIBERTY AVE, ST 1700 PITTSBURG, PA 15222 (724)873-3645				
LOCATION:	Spread E MP143 to MP152.2 approx. and AR #182			Entry Date/Time:	8-14-2019 @ 13:00
COUNTY:	Greenbrier			Exit Date/Time:	8-14-2019 @ 17:00
Site Representative /Phone	Jonathan Houde, LEI Spread E, 304 575-6113 Jon Larson, EC Spread E, Price Gregory, 309 333-7379			PHOTOS <input checked="" type="checkbox"/>	
CO-PERMITTEE:				ADDRESS:	
SITE OPERATOR:	Price Gregory			ADDRESS:	920 Memorial Way, Ste 600, Houston TX, 77024
PERMITTED ACREAGE	4311	WEATHER:	Sunny	LAST INSPECTION:	N/A
RECEIVING STREAM(S)	UNTs/Meadow Rv/New Rv/Kanawha Rv				NOV: 0
Regular Mail <input checked="" type="checkbox"/> Certified Mail <input type="checkbox"/>		Tracking #			
OVERALL FACILITY RATING:	Satisfactory		COMPLIANCE OUTCOME	No Violation

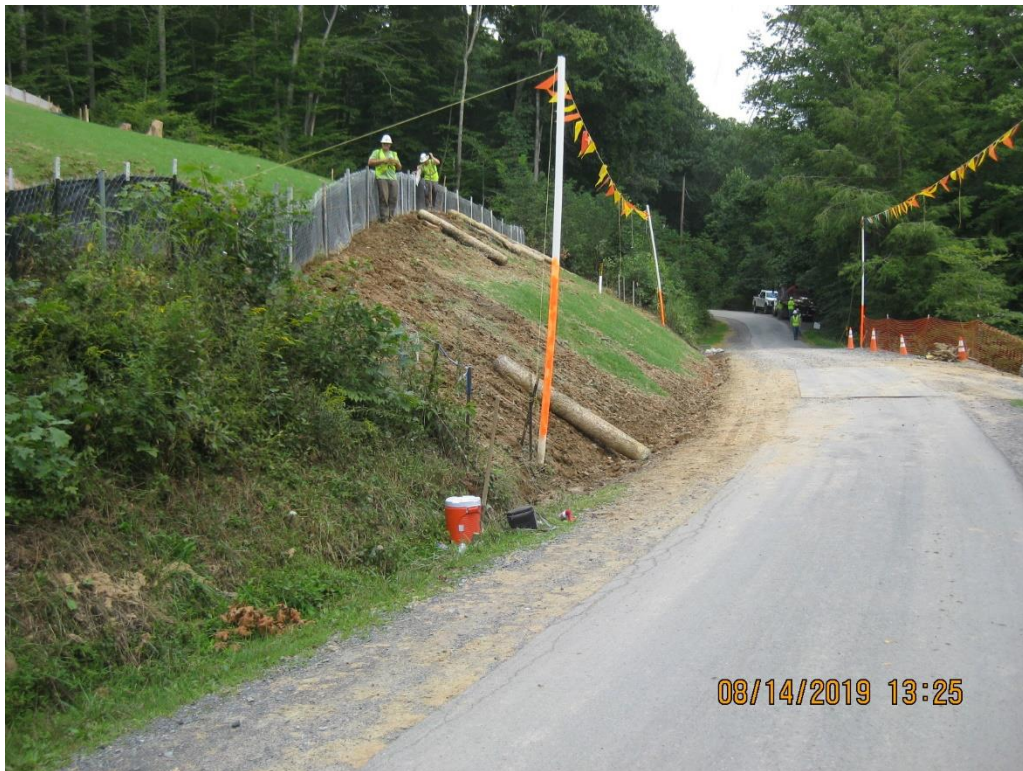
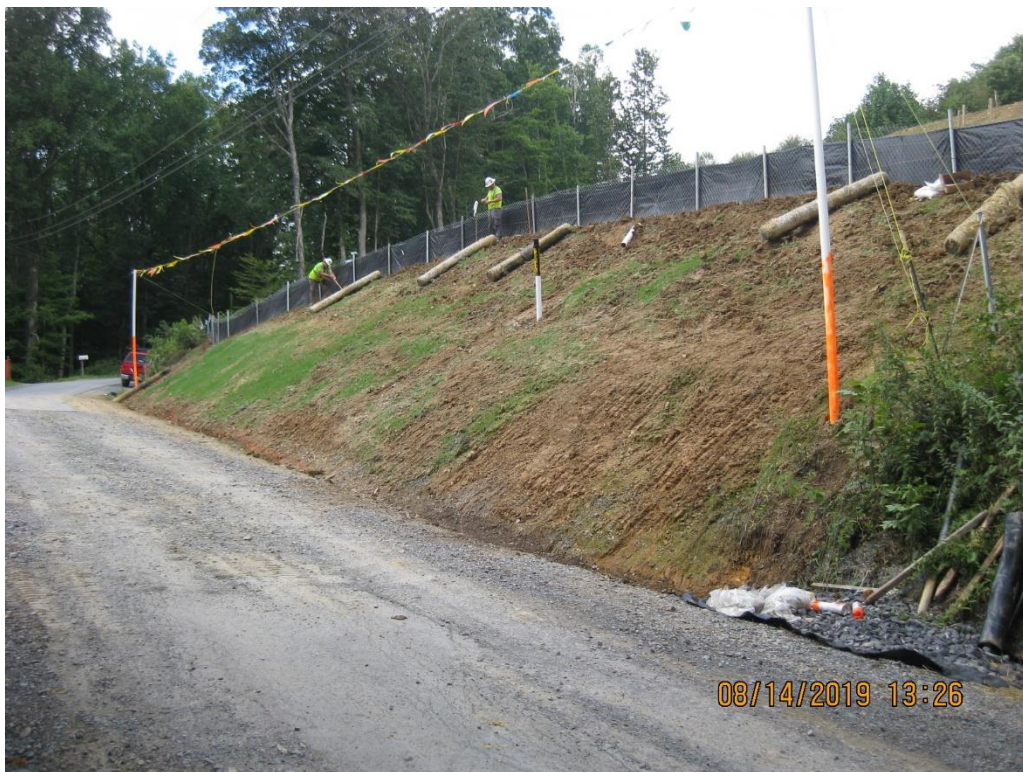
Complaint 1: ROW at Crozier Rd. BMPs were in place and final restoration is ongoing.

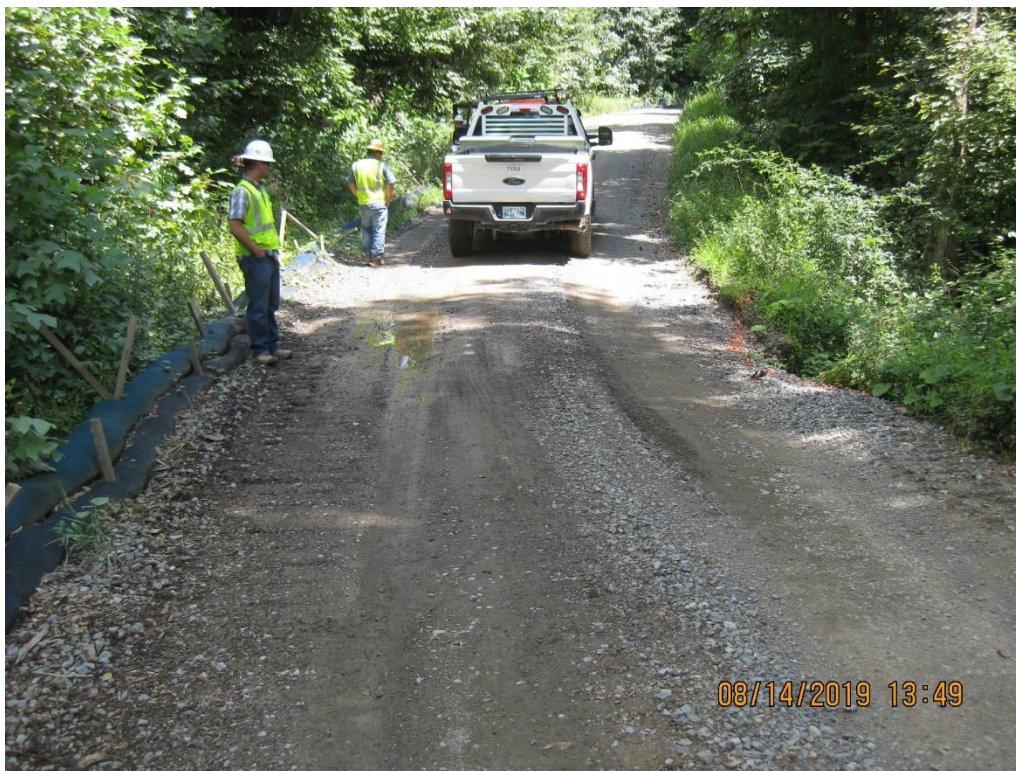
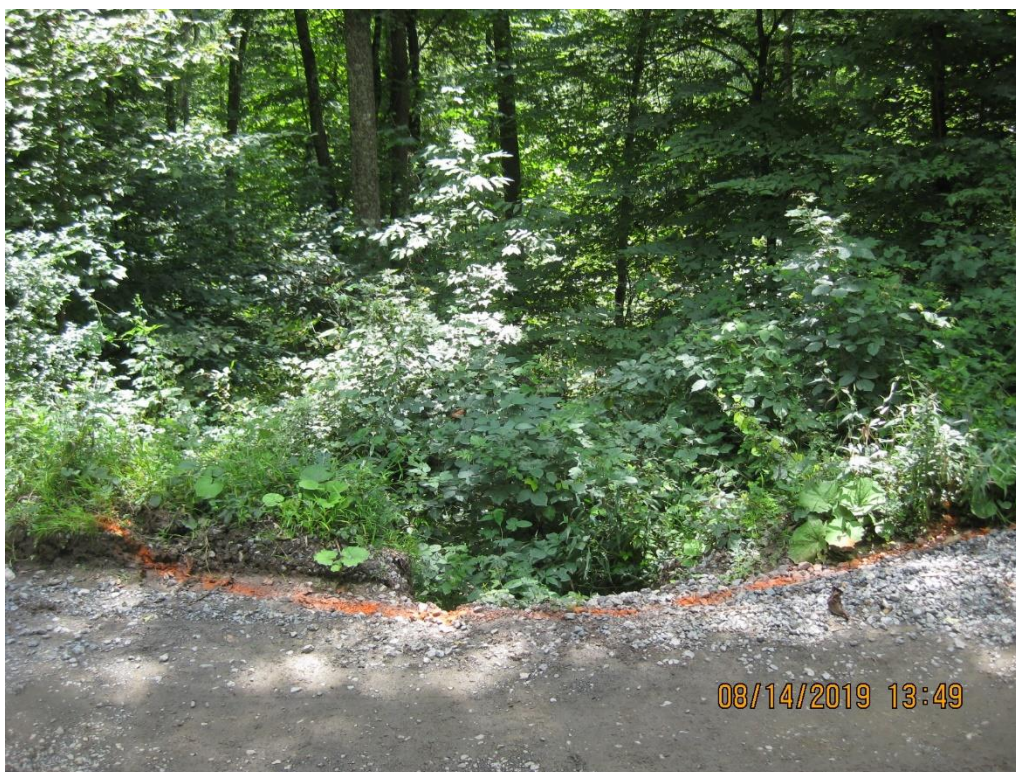
Complaint 4: No significant noncompliance was noted. Recommended additional stone on roadway at water crossing and protection on the downslope side of roadway.

Complaint 4: AR 182. No significant noncompliance was noted. Recommended additional stone on roadway at water crossing and protection on the downslope side of roadway.

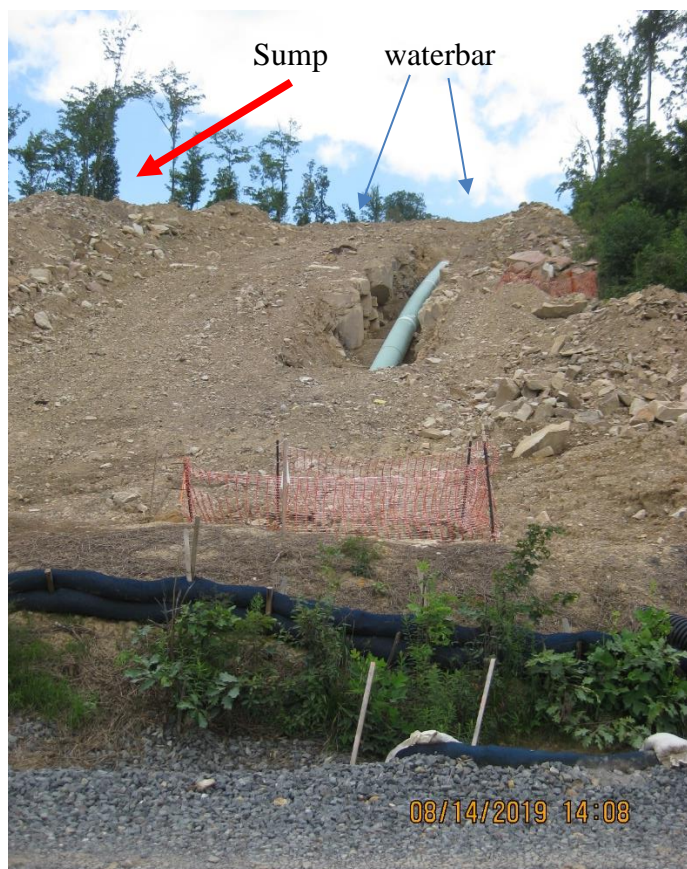
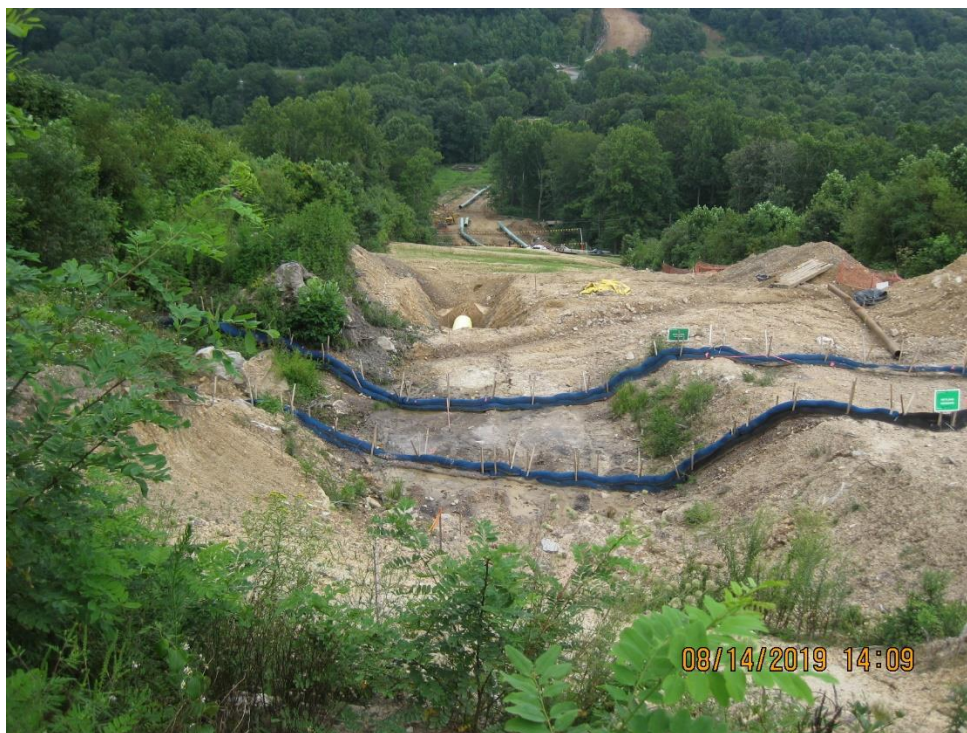
Complaint 5: Intersection of AR 182 and ROW at St. 7596. Controls in place. Waterbars in place upgradient of open pipe trench both above and below AR 182.

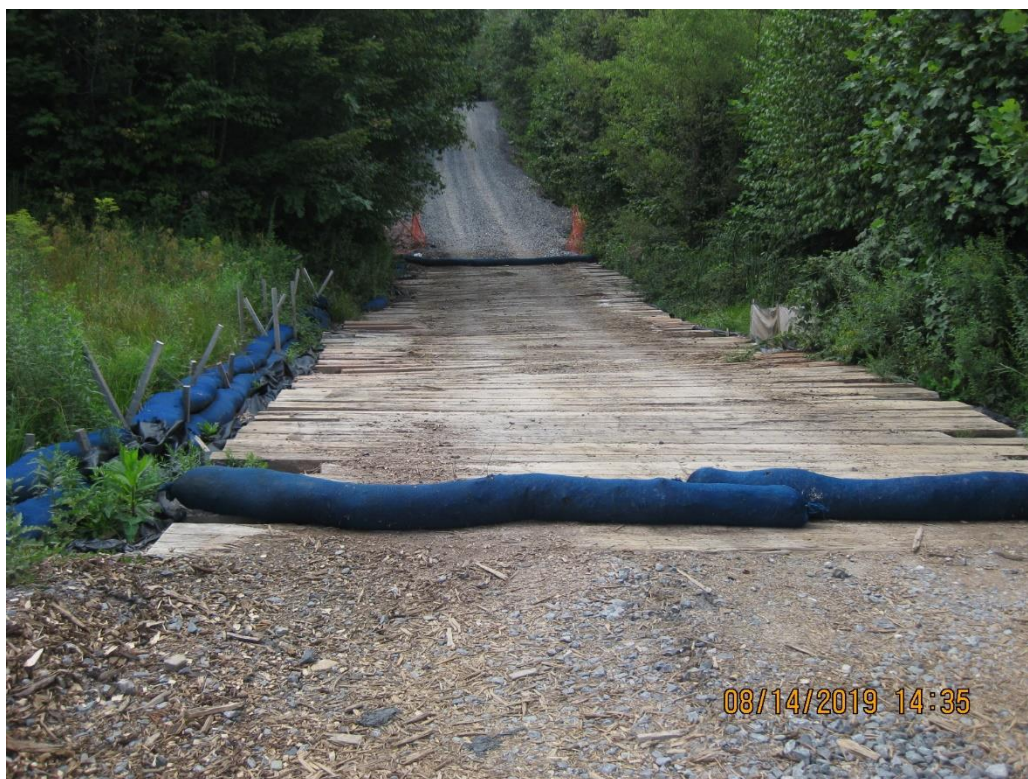
Complaint 6: Bridge crossing wetland on AR 182. CFS in place on both ends of bridge and roadway is stabilized. Filter fabric along the side of bridge is in disrepair but also unnecessary. Recommended removal of bridge filter fabric.

Complaint 6: Bridge crossing wetland. CFS in place on both ends of bridge and roadway is stabilized.

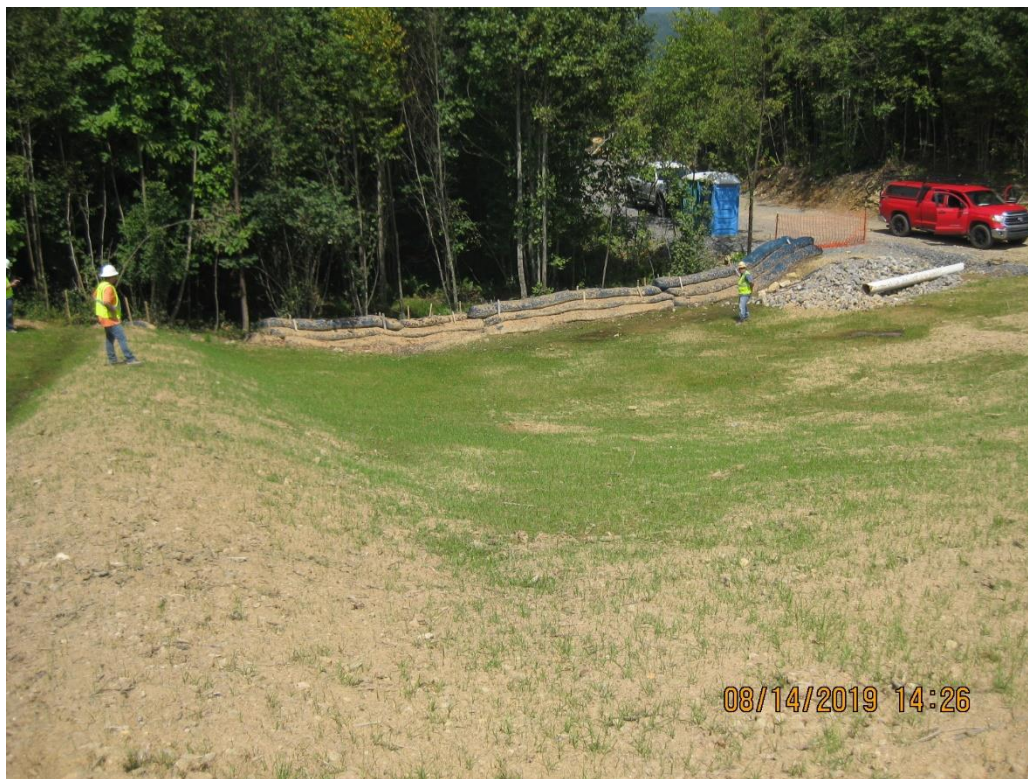
Complaint 7: Northern terminus of AR182. Sediment loss of ROW was address in a previous inspection conducted by Jason Liddle. BMPs in this area have been significantly enhanced and sediment deposits have been remediated. The land disturbance in the area of the ROW has been put to final grade and stabilization measures have been initiated.

Complaint 7: Northern terminus of AR182.
BMPs in this area have been significantly enhanced and sediment deposits have been remediated.

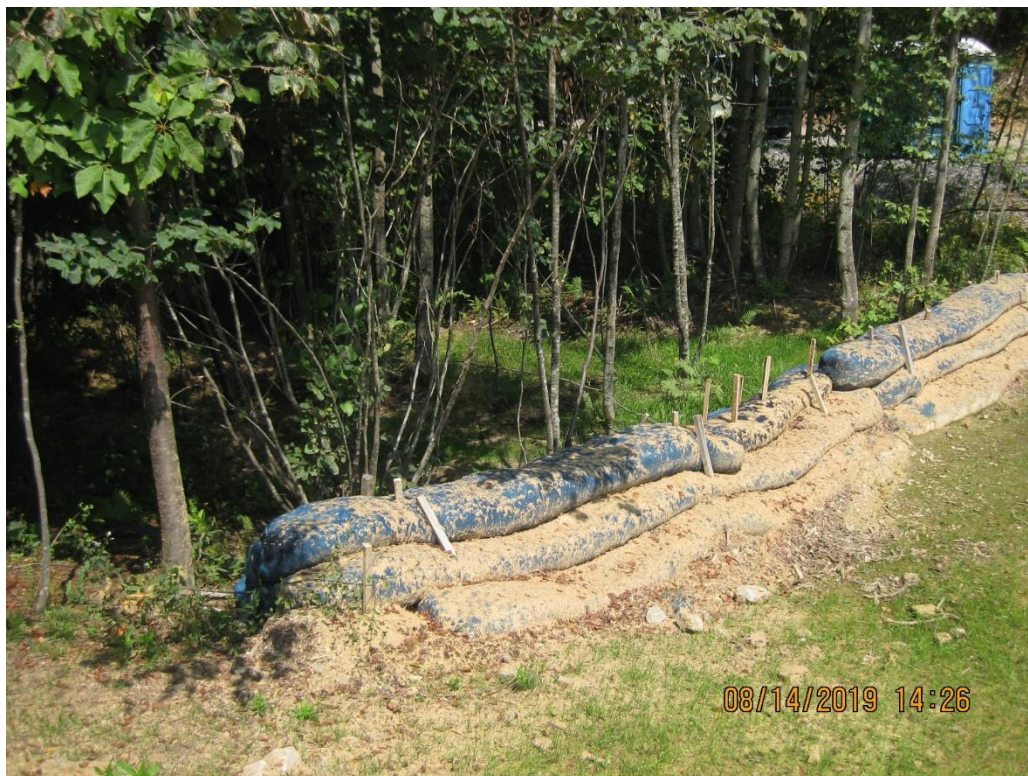
Complaint 7: Northern terminus of AR182.

BMPs in this area have been significantly enhanced and sediment deposits have been remediated.

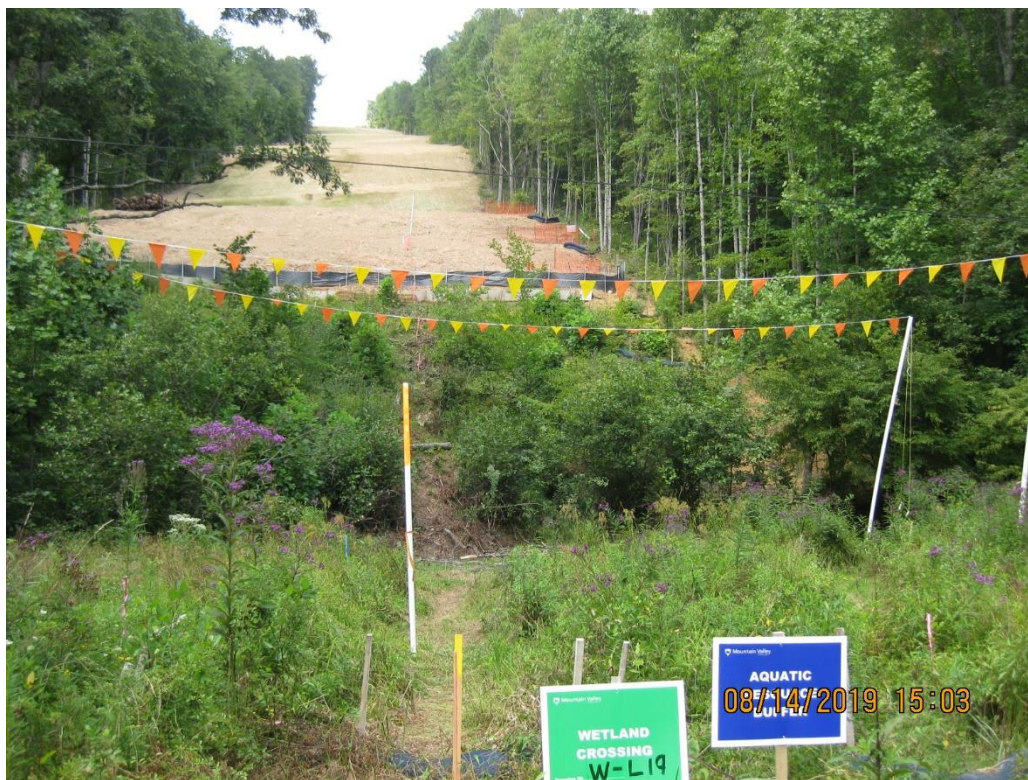
Wetland W-L19 at St. 7770+52. Anomalous rain event inundated controls resulting in deposits in wetland W-L19. Controls have been repaired and enhanced. Deposits have been removed from wetland area.

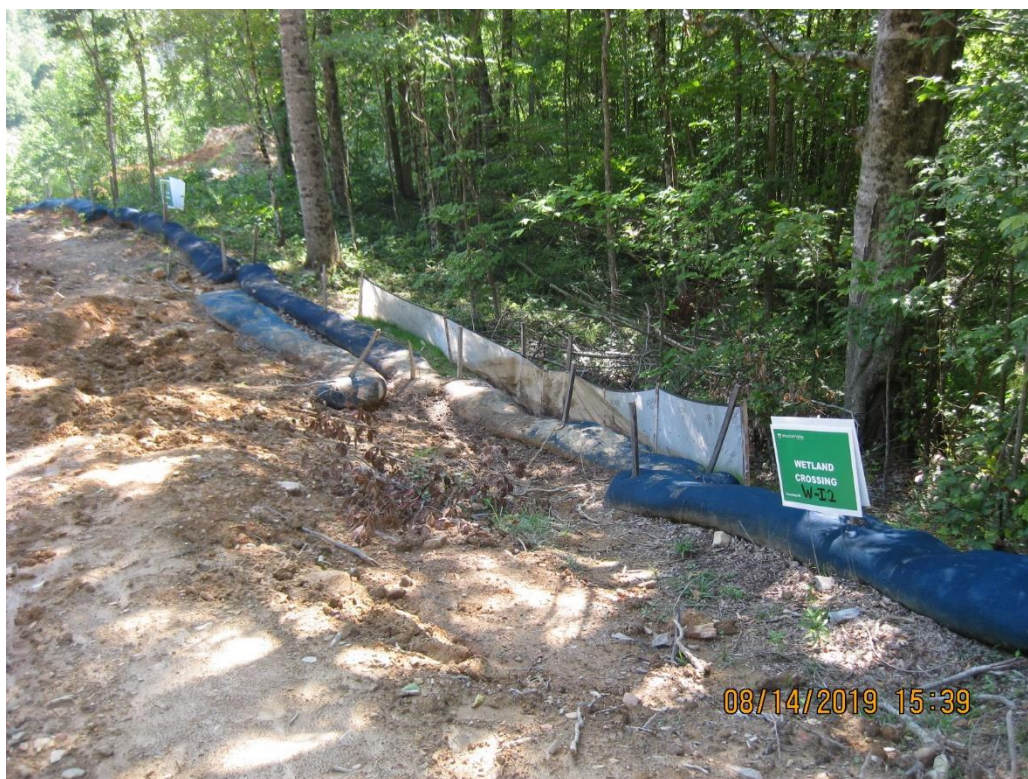
Wetland W-I2 at St. 7921. Anomalous rain event inundated controls resulting in deposits in wetland W-I2. Controls have been repaired and enhanced.

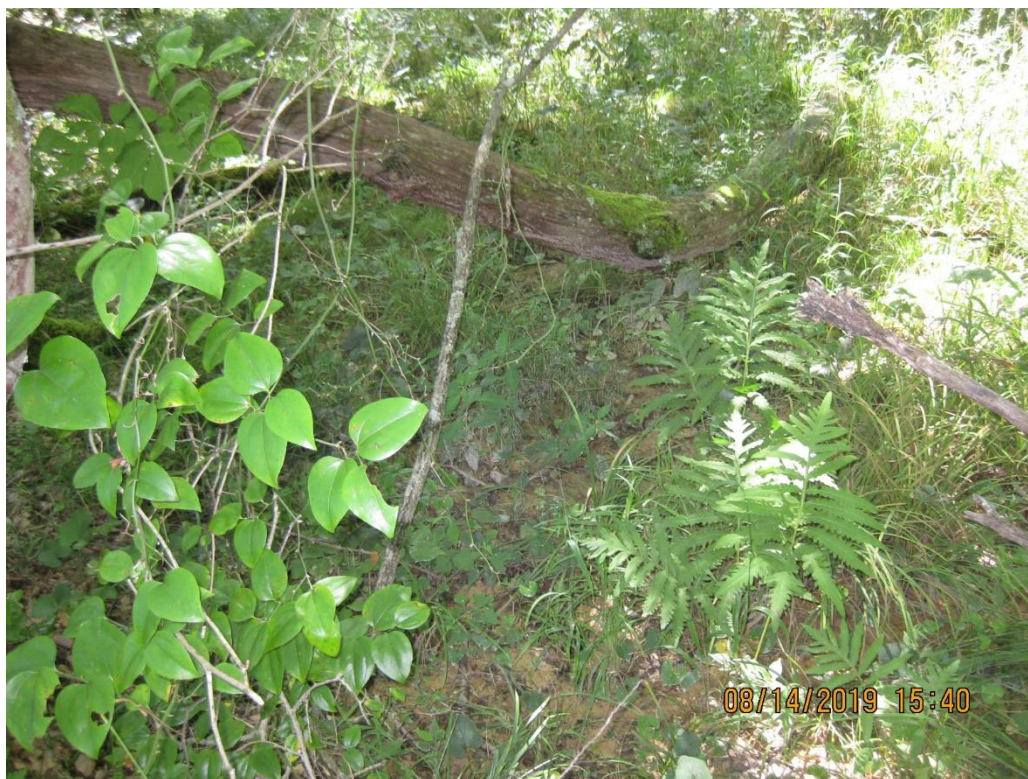
Wetland W-I2 at St. 7921. Deposits to be removed from wetland area when feasible, area currently too saturated.

Wetland W-I2 at St. 7921. Anomalous rain event inundated controls resulting in deposits in wetland W-I2. Controls have been repaired and enhanced. Deposits to be removed from wetland area when feasible, area currently too saturated.

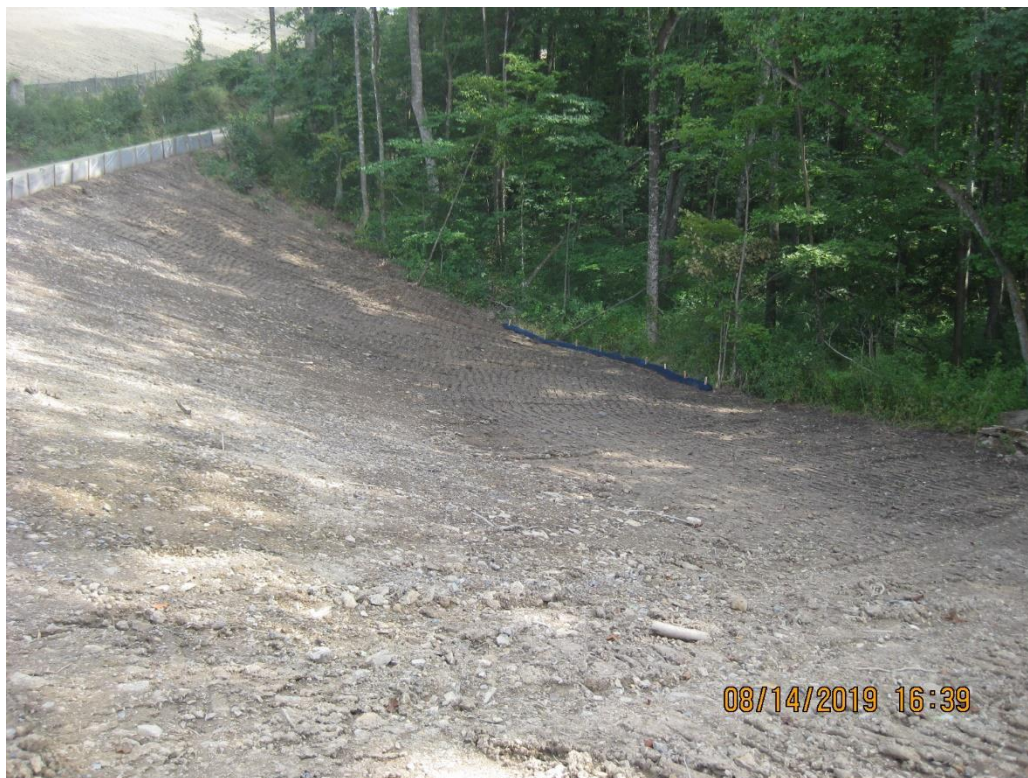
Complaint 9: St. 8100 of ROW. Project at final grade with stabilization measures being initiated. BMPs for this phase of the project have been installed per the SWPPP.

Complaint 9: St. 8100 of ROW. BMPs for this phase of the project have been installed per the SWPPP. Area ready for seeding. 1 inch of rain the previous day showed no evidence of SLW leaving the ROW.

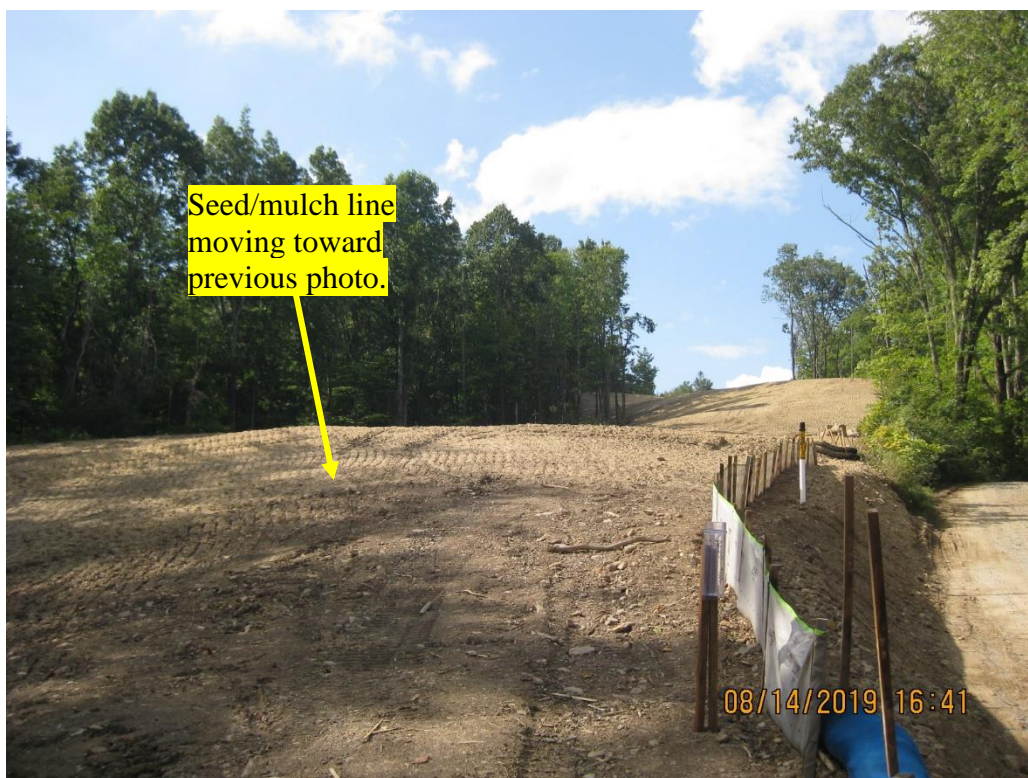
Complaint 9: St. 8100 of ROW. Area adjacent to previous photo showing progress of seed and mulch application.

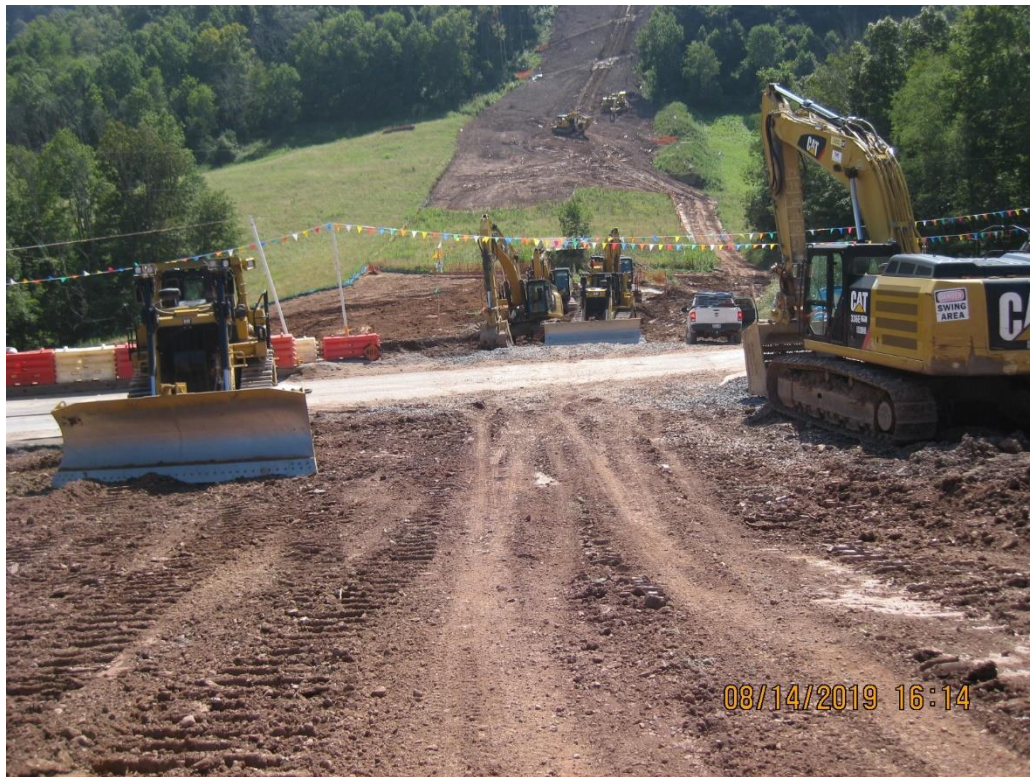
Complaint 10: St. 8002+43 of ROW. BMPs in place in this area.

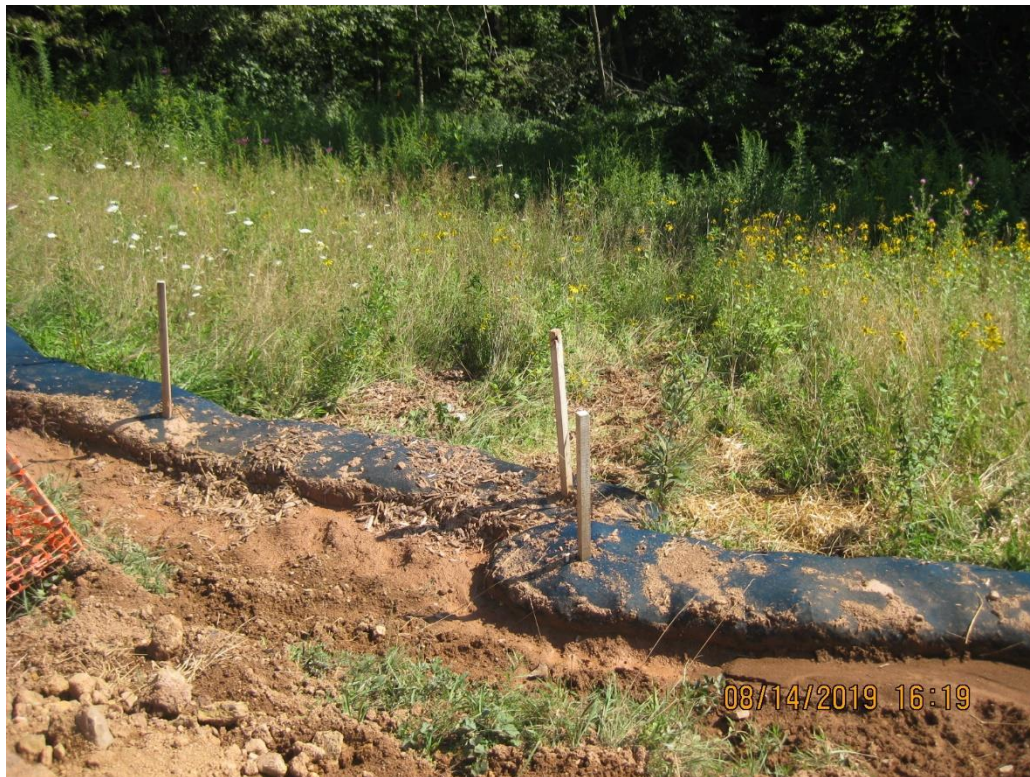
Complaint 10: St. 8002+43 of ROW. BMPs in place in this area. There was evidence of stormwater discharging offsite into a large vegetative buffer, on a mild grade, far away from any receiving waterbody. There was a small amount of mulch present beyond the LOD. After a discussion it was agreed to add another layer of E and S control as an enhancement for assurance.

Complaint 10: St. 8002+43 of ROW. There was evidence of stormwater discharging offsite into a large vegetative buffer, on a mild grade, far away from any receiving waterbody. There was a small amount of mulch present beyond the LOD. After a discussion it was agreed to add another layer of E and S control as an enhancement for assurance.
